NASA Contractor Report 4312

Design and Evaluation of Candidate
Pressure Distribution and Air Data
System Tile Penetration for the
Aeroassist Flight Experiment

CONTRACT NAS1-19000
SEPTEMBER 1990

Alfred E. Von Theumer
Lockheed Engineering & Sciences Company
Hampton, Virginia

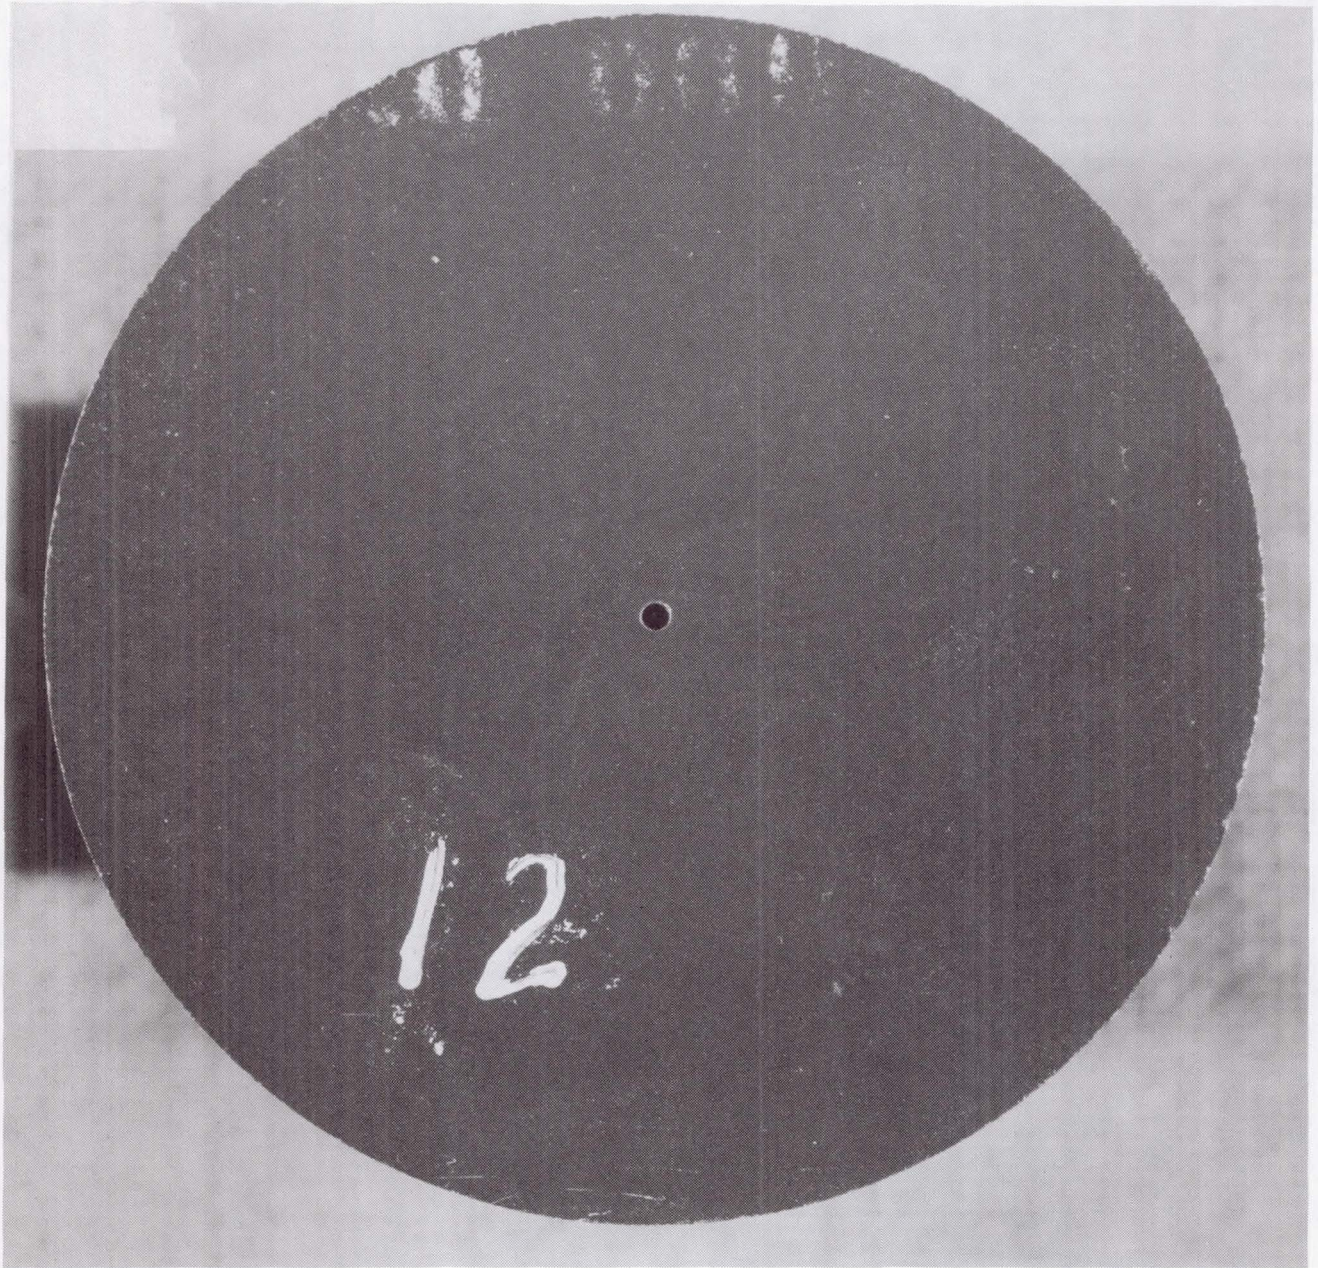
Figure 17

Pretest 3-F12FB-159, 2700 degrees F
fully bonded, front view

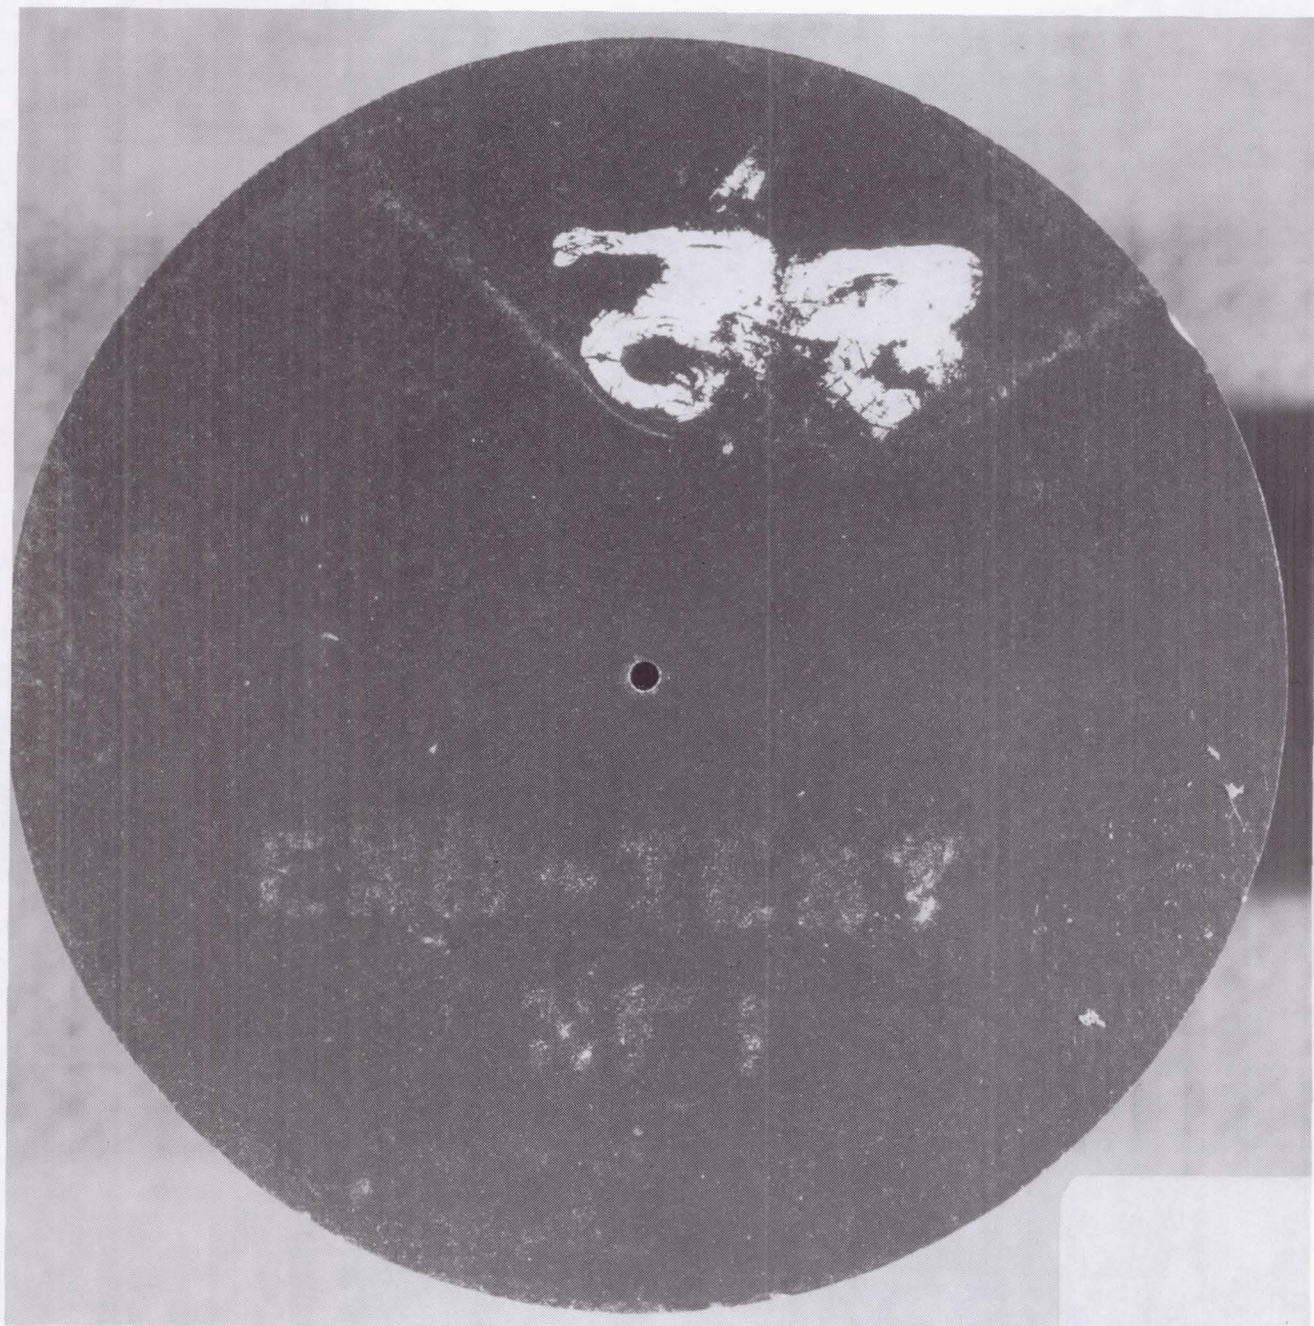
Figure 40

Pretest 2-L22FB-158, 2900 degrees F
fully bonded, front view

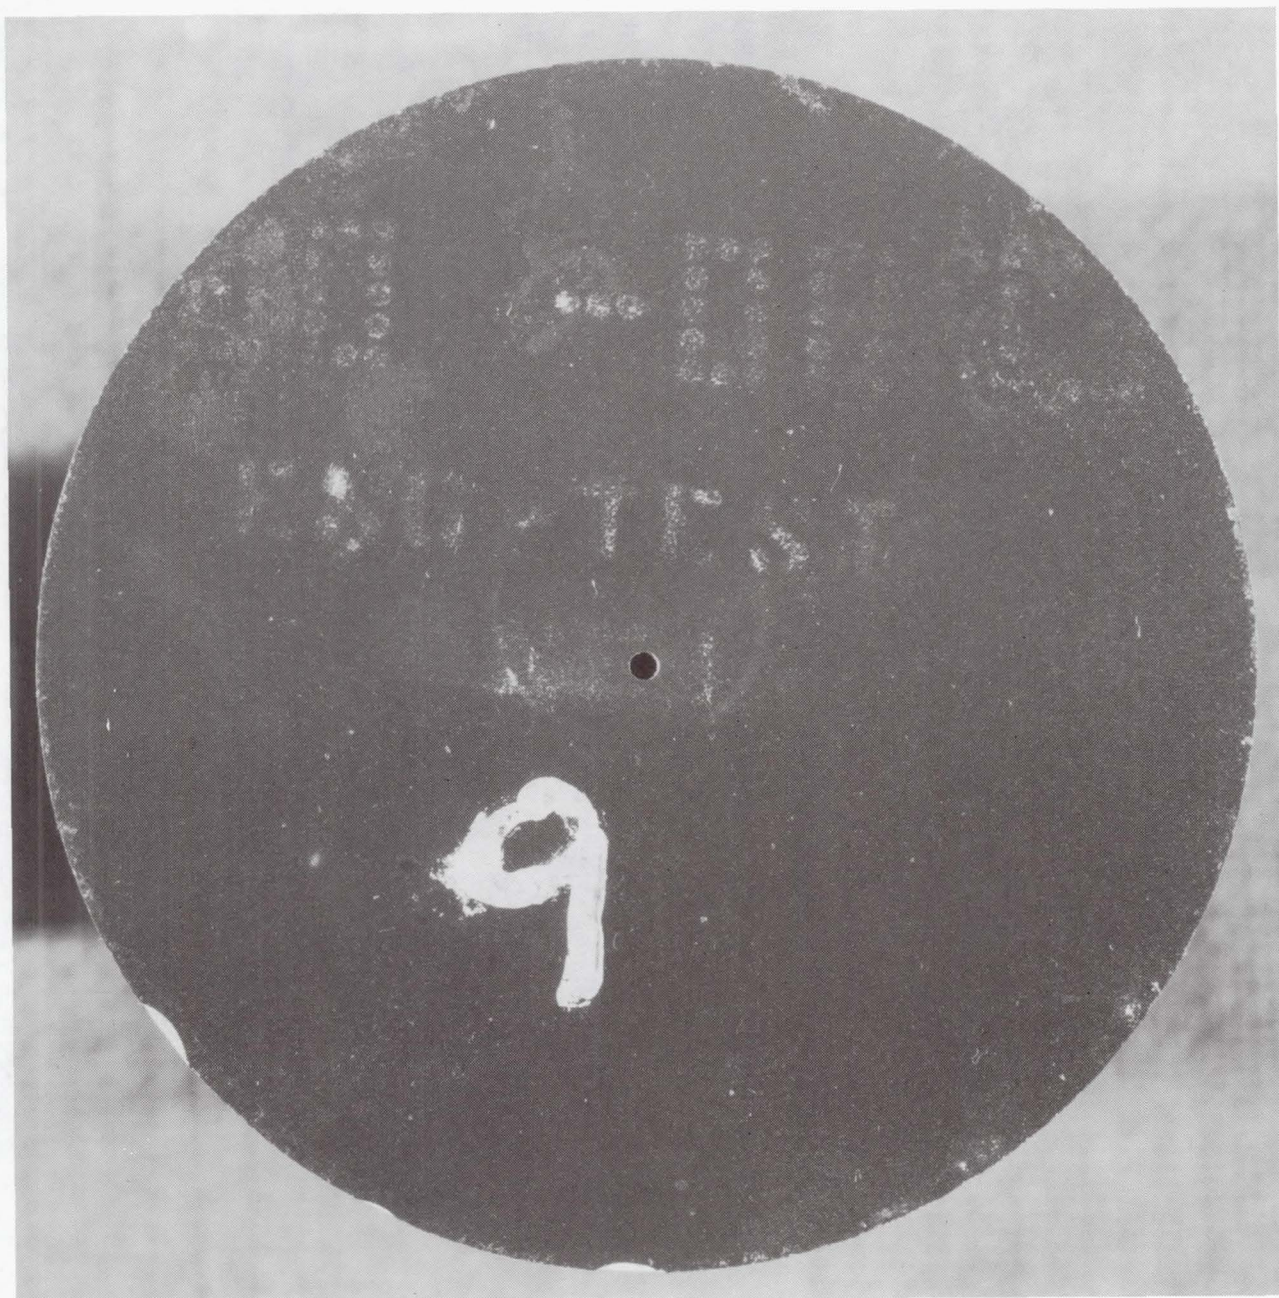
Figure 41

Pretest 6-L9-162, 2300 degrees F
partially bonded, front view

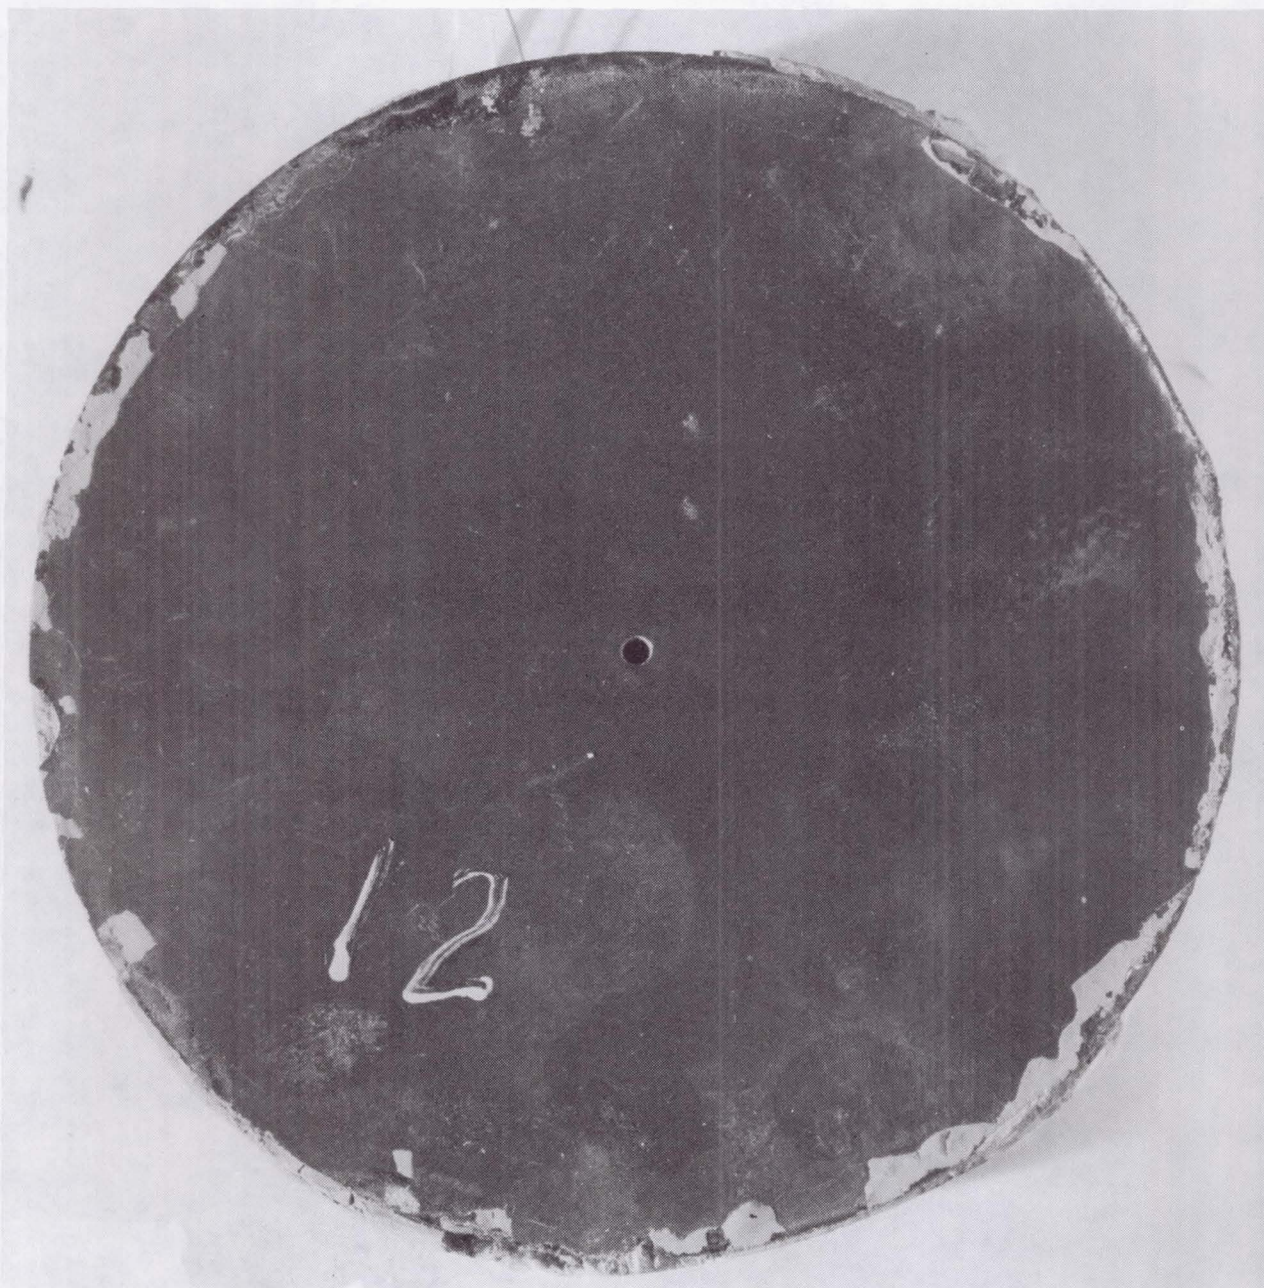
Figure 44

Post Test 3-F12FB-159, 2700 degrees F
fully bonded, front view

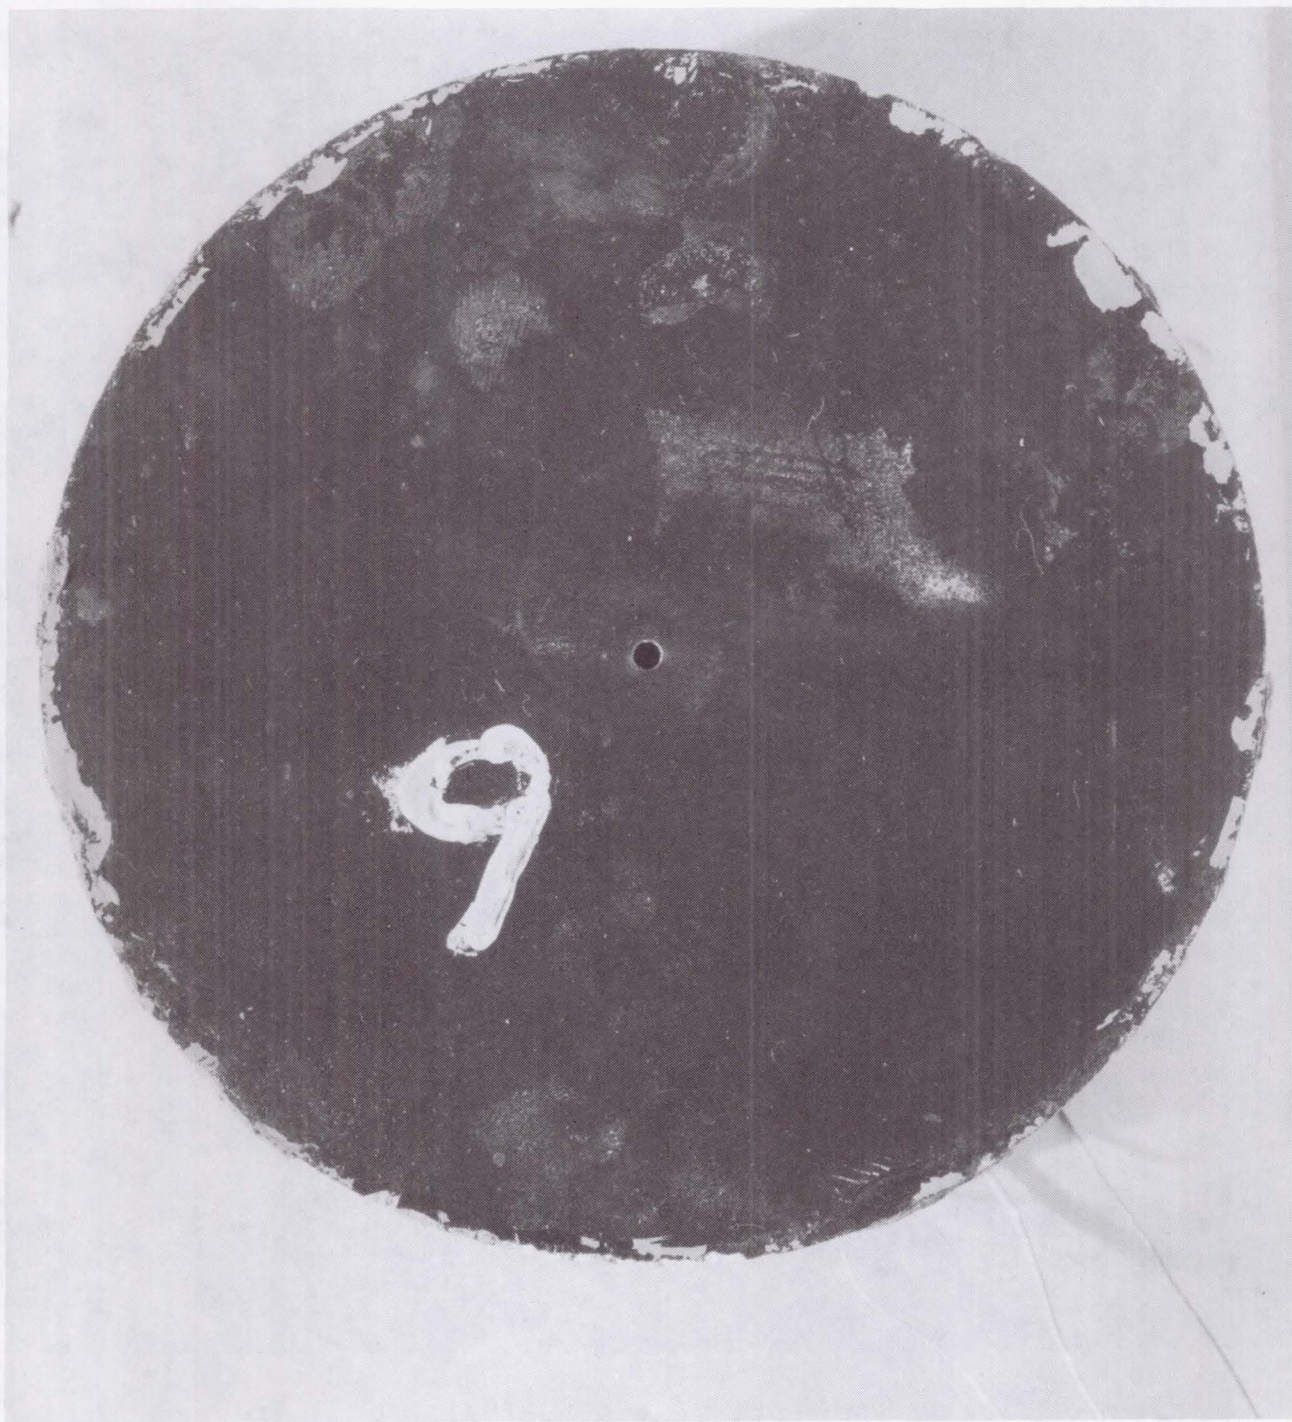
Figure 46

Post Test 6-L9-162, 2300 degrees F
partially bonded, front view

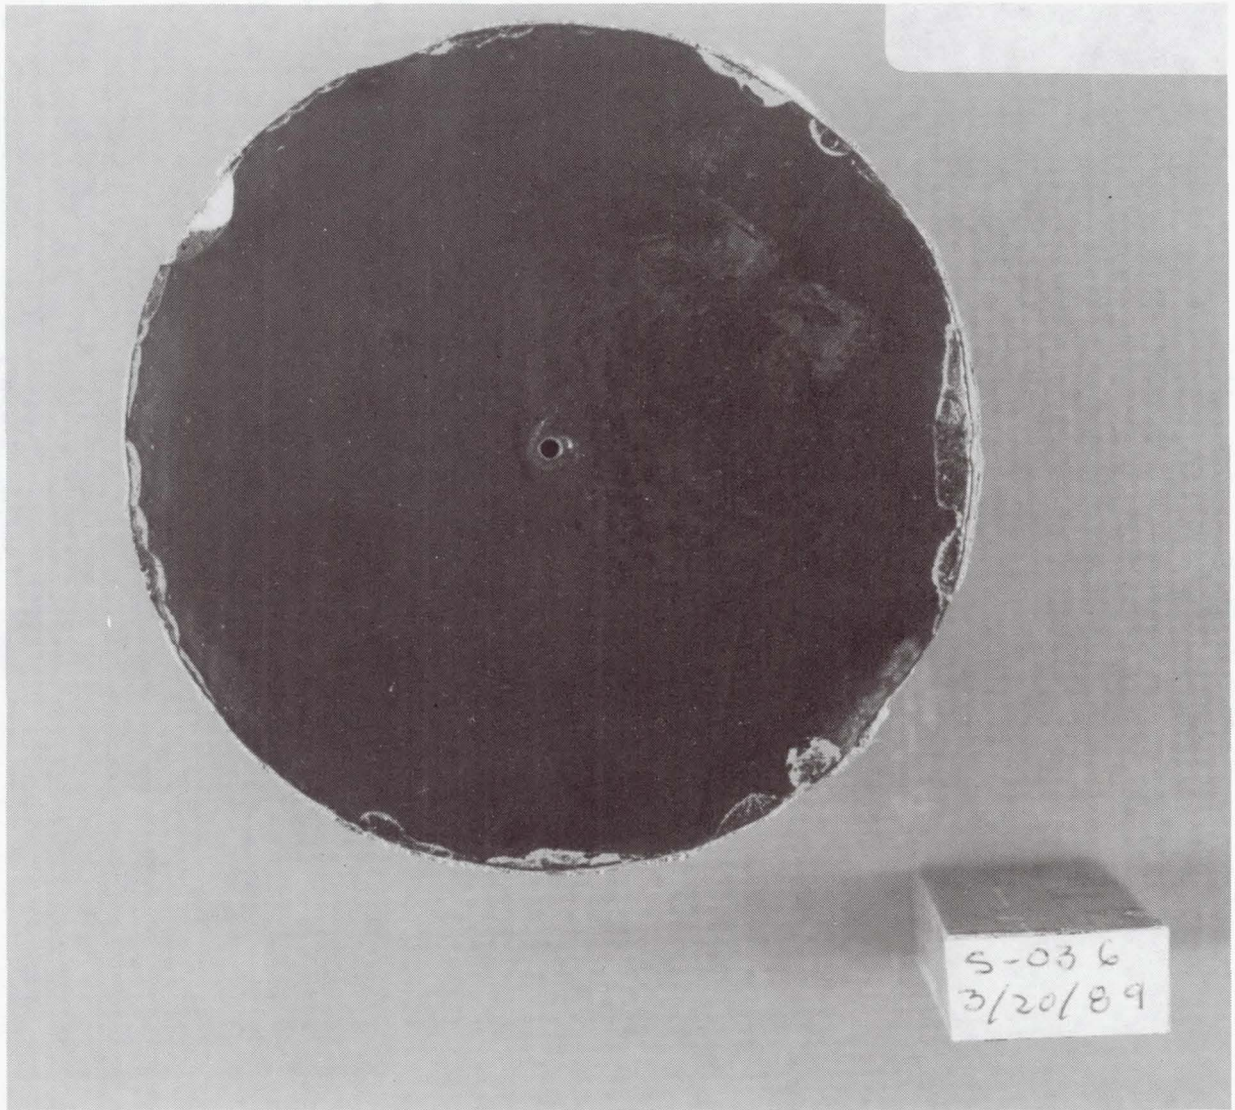
Figure 59

Post Test 2-L22FB-158, 2900 degrees F
fully bonded, front view

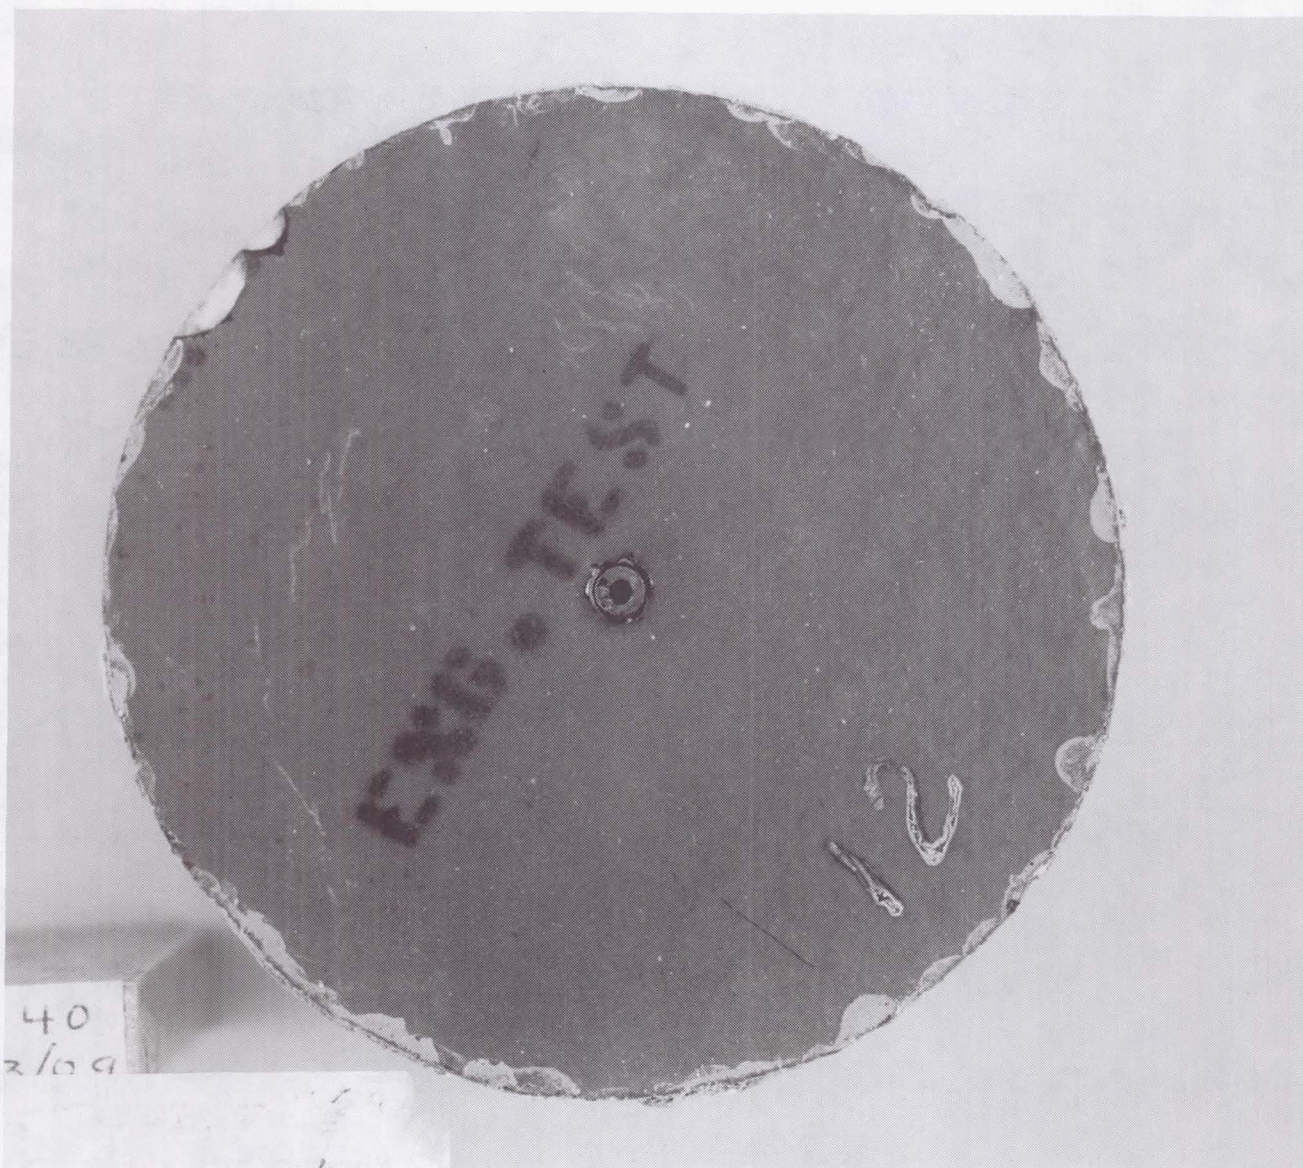
Figure 82

Post Test 8-F12-164, 2nd Run 2700 deg. F
Tube Failure Test, front view, showing
RCG re-flow

Another follow on test was performed to determine the effects of a fractured RCG coating over the area of the pressure tube tip. This failure mode was also confirmed to be benign for FRCI-12 insulation tile, where the surface temperature was 2700 degrees F.
